Using Smart Technology in Conservation of The Ancient Egyptian Monuments from Environmental Impact and Anthropic Factors

Gehan Ahmed Elsayed

Associate prof. Head of Architecture Department Modern University for Information and
Technology
gehanelsayed2@yahoo.com

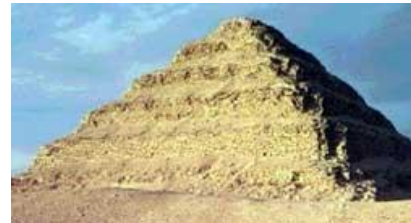
figure (1) step pyramid
source: (step pyramid, 2021)

The step pyramid was built with the figure of six terraces above a tunnel which goes down to the place of burial. The six terraces of the pyramid decrease in size until they reach a height of 60 m. The pyramid's base is rectangular of dimensions 130m x 110m. The height of the first terrace is 8m

Approximately 8m and each terrace is higher than the previous one by 2m. The Pyramid is encompassed by a rectangular encased divider that measures 277 m by 544 m, generally destroyed today, yet it was originally 10m high. You can see parts of it today. The vast majority of the external covering of the pyramid is gone and sooner or later a few sections of the principle building will vanish. The eastern side offers the best view; however, it can also be seen from the north and south. The first terrace from the stepped pyramid was the first squared royal tomb, each side is of length 63 m & its height is 8m. It was constructed from stone which was cut down from quarries of Saqqara. However, the external coverage stones for this terrace or the other terraces were built above the first terrace later on. (Figure 1). (Magli 2009)

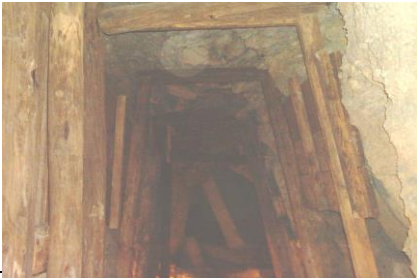
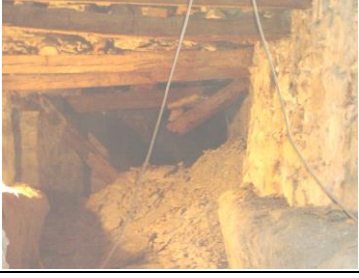
- A temporary wooden support had been erected but it can't resist the movement and it collapsed in some parts, but no documents have been found for when and how it has been executed Figures 8 (a, b).

Figure 8 (a) Tomb chamber shaft roof	Figure 8 (b) Tomb chamber roof
source: ("inside step pyramid", 2021)	
<p>The tomb chamber shaft roof is a roughly constructed dome. All of stones are irregular and some of the smaller stones have fallen. There is evidence of temporary shoring, parts of which remain in place. On top this structure there are relatively large pieces of loose stone. The greatest problem confronting the repair of this dome is one of safe access. A temporary scaffold from both steel bars and wood was used to support the rocks of the roof of the tomb chamber. But it is not effective, and it is causing destruction method to the masonry dome and walls. (Figure 9)</p>

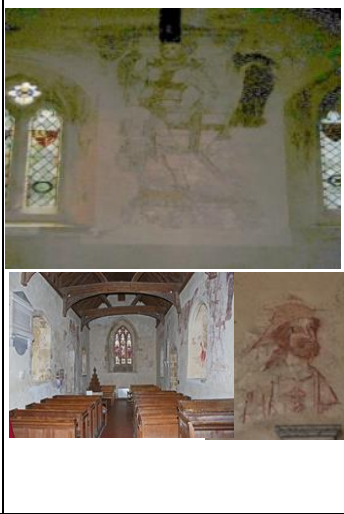
<p>(fig11): A graphics on the stone walls of the church, and the picture is clear from the appearance of small cracks and open pit wall. source: (All Saints Church, Little Kimble England, 2021)</p>

<p>Restoration work began in 1930, with the restoration of the walls of the church covered with wax and was considered the best treatment time, but with the passage of time has shown this type of restoration failing in the face of the various factors of moisture and salts exposed archeological buildings in England constantly, where through the viewfinder Studies the appearance of cracks and crevices walls which shows the separation between the layers of stone and gypsum user.</p> <p>* the presence of insects and dirt Kanakp bat on graphics that distinguish stone walls Church, which was produced by the presence of small pits and cracks walls and the disappearance of a large portion of those graphics effect, as shown in the [Figure11]</p>

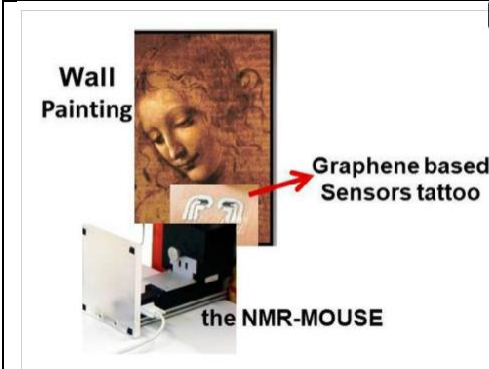
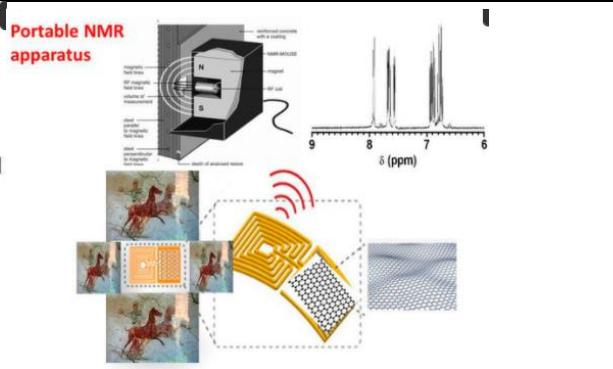
<p>raphene-based tattoo/combined with the movable NMR apparatus, for several applications: sensors directly applied on cultural heritage surfaces (to identify the composition of black crust layers); actuators suitable to remove environmental black crust/patinas and to provide (for example, as a case study) free water molecules, having short relaxation time, essential to produce a significant NMR signal profile/spectra. [Tapete et. all, 2012] Figure 23 ("nmr spectrometer diagram", 2021)</p>

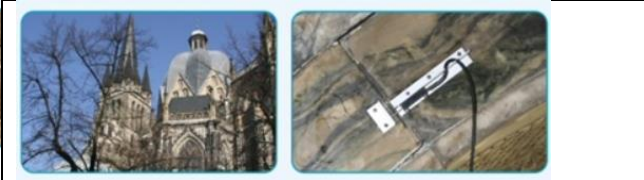
<p>Church of the annunciatin of the blessed virgin mary in Nazareth</p>	<p>World heritage site Aachen cathedral (charlemagne) Roman Catholic church in Aachen, Germany</p>
<p>Fully automatic recording of crack displacements, air temperature and humidity thanks to the high-resolution crack analysis sensor system and the revolutionary digital CMOSens® technology [Tapete et. all, 2012] Figure 24 ("high-resolution crack analysis sensor system and the revolutionary digital CMOSens® technology - Google Search", 2021)</p>

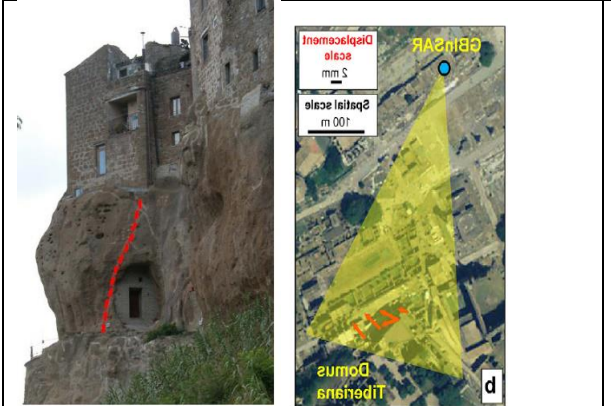
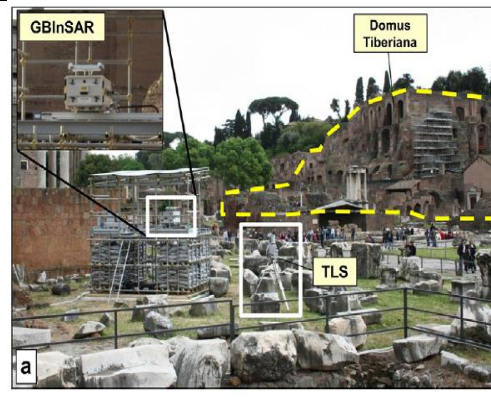
<p>The area selected on the southern side of the pitigliano cliff italy. Deformometers were installed to monitor the joint (dashed line) which controls the wedge geometry. Spatial relationship with the overlying building suggests probable direct impacts on the preservation of the built heritage(Figure 25)</p>	<p>On site istallation and radar data acquisition of Roman forum. The GBInSAR lisamobile, mounted on stable scaffoldings, with view centred on the domus tiberiana [dashed yellow line] Figure 26</p>
<p>Source: [Tapete, D., et. al, 2013]</p>

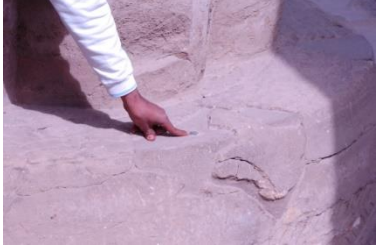
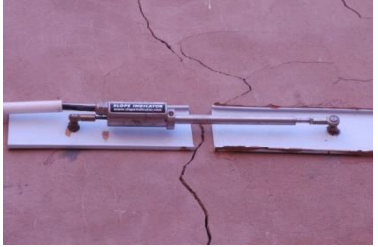
<p>Figure (27) : Monitoring of column settlement using fixed points measured periodically by surveying total station, Karnak temple</p>	<p>Figure (28) : Monitoring of crack using slope indicator, with manual readout unit, Karnak temple By researcher</p>

It is the integrated system, which monitors and documents the geological and physical characteristic changes of the site and the Anthropic factors. Some of the archaeological sites in Egypt follow the old traditional management methods to conserve the archaeological sites which depending on personal human skills and primitive tools to give a critical description of the present condition of the property and its OUV-AI using physical attributes that will allow measurement of change over time. (Figure 27,28) (Rowberry 2012)
